# MH17

A False Flag Terror Attack

A summary of the evidence

First edition, November 2021

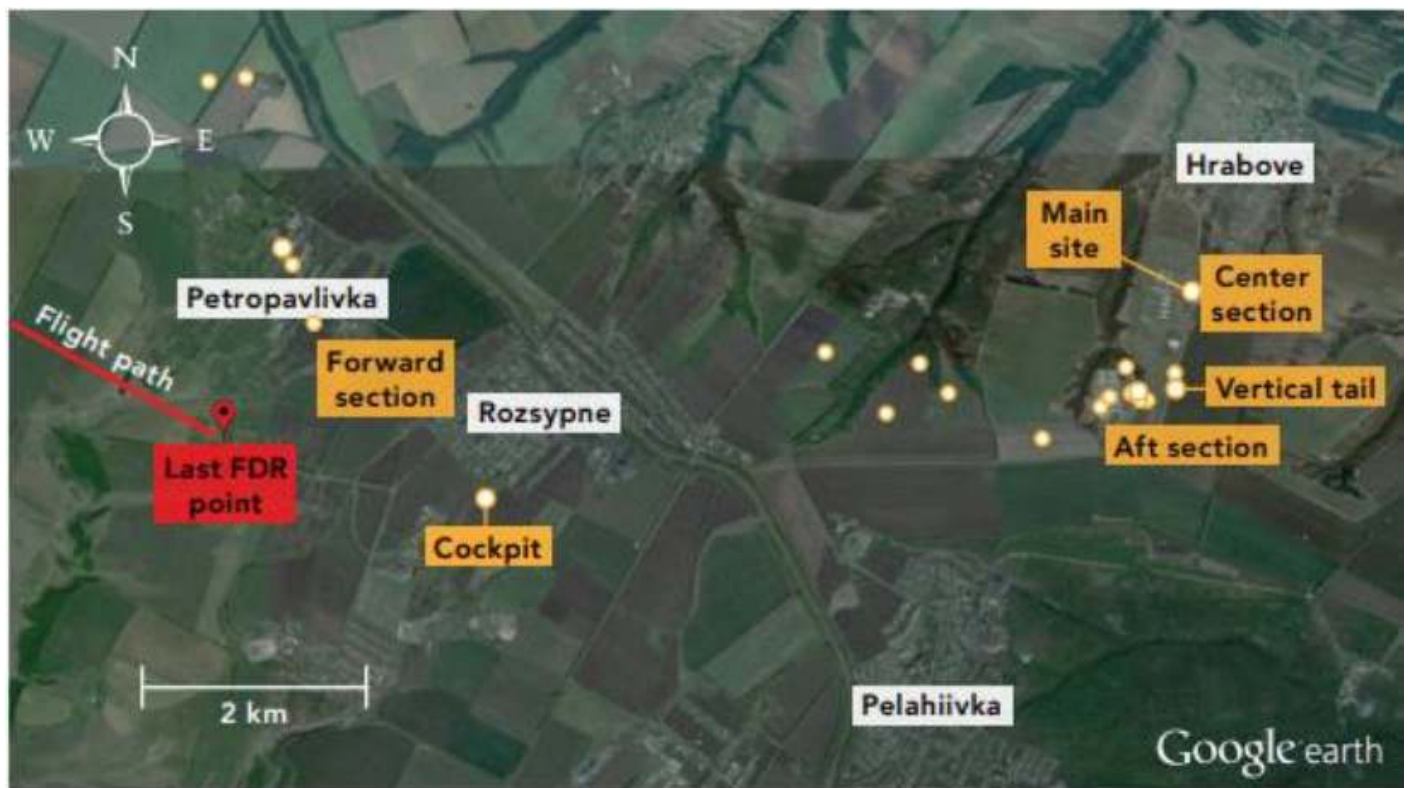
Figure 6: The last location of the aircraft in flight taken from the FDR. Wreckage distribution is grouped per section of the aircraft (Source: Google Earth, wreckage information Dutch Safety Board).

The initial 16-meter segment of MH17 was recovered near Rozsypne and Petropavlivka, while the subsequent 48-meter section (excluding the left engine intake ring) was located at Hrabove.

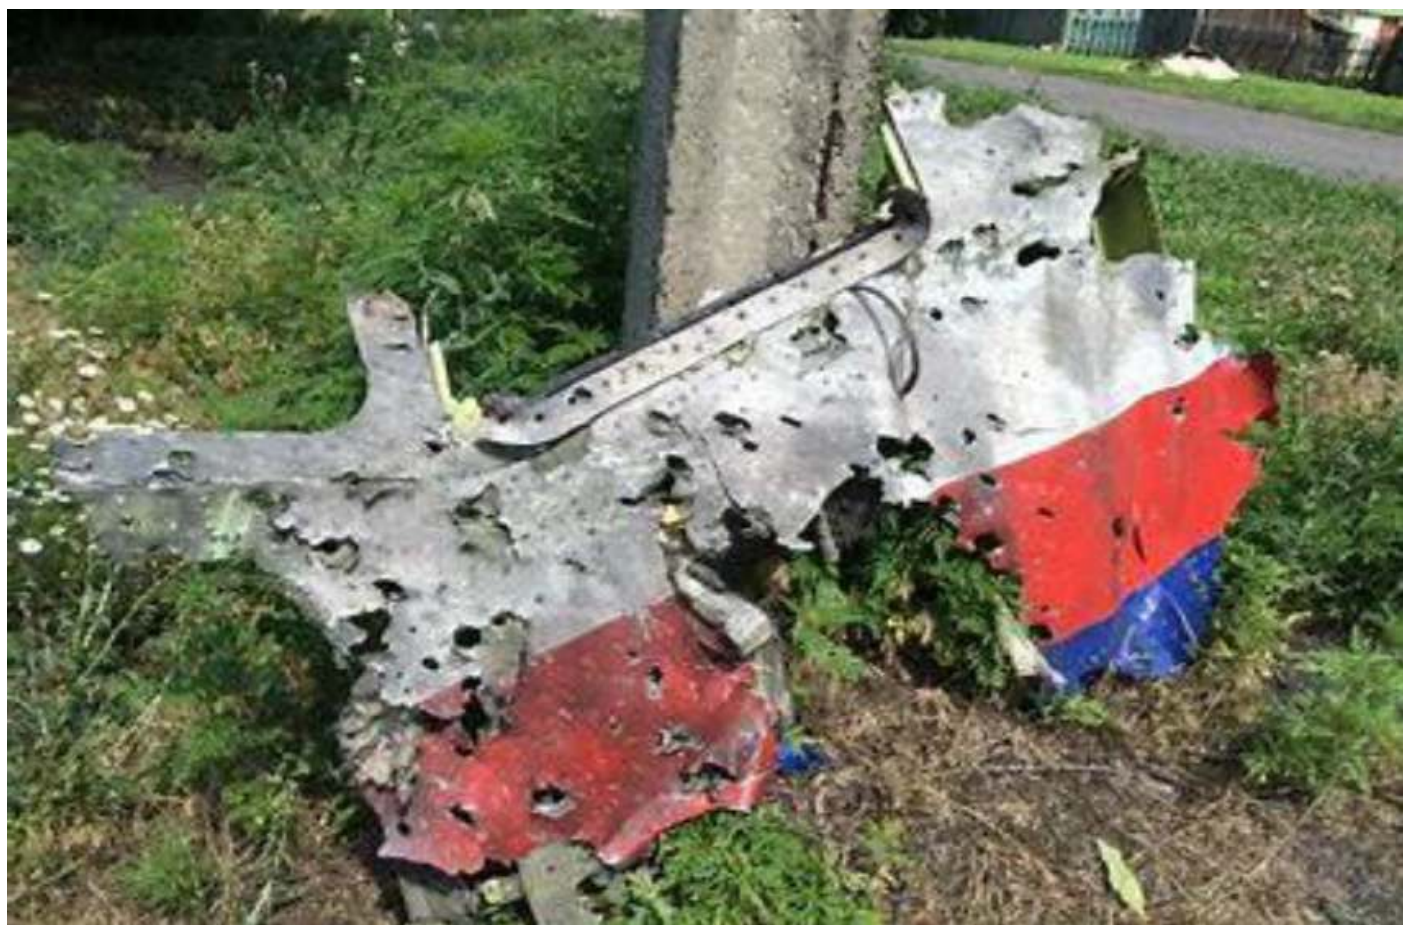
The plating on the lower section of the left cockpit window frame (designated as crucial evidence by Jeroen Akkermans) reveals multiple complete and partial 30 mm holes. Buk missile shrapnel cannot produce such precisely round 30 mm holes.

Petalling refers to the formation of protrusions when projectiles or Buk shrapnel penetrate dual metal layers. This phenomenon occurs particularly where plate material is riveted to rigid steel components.

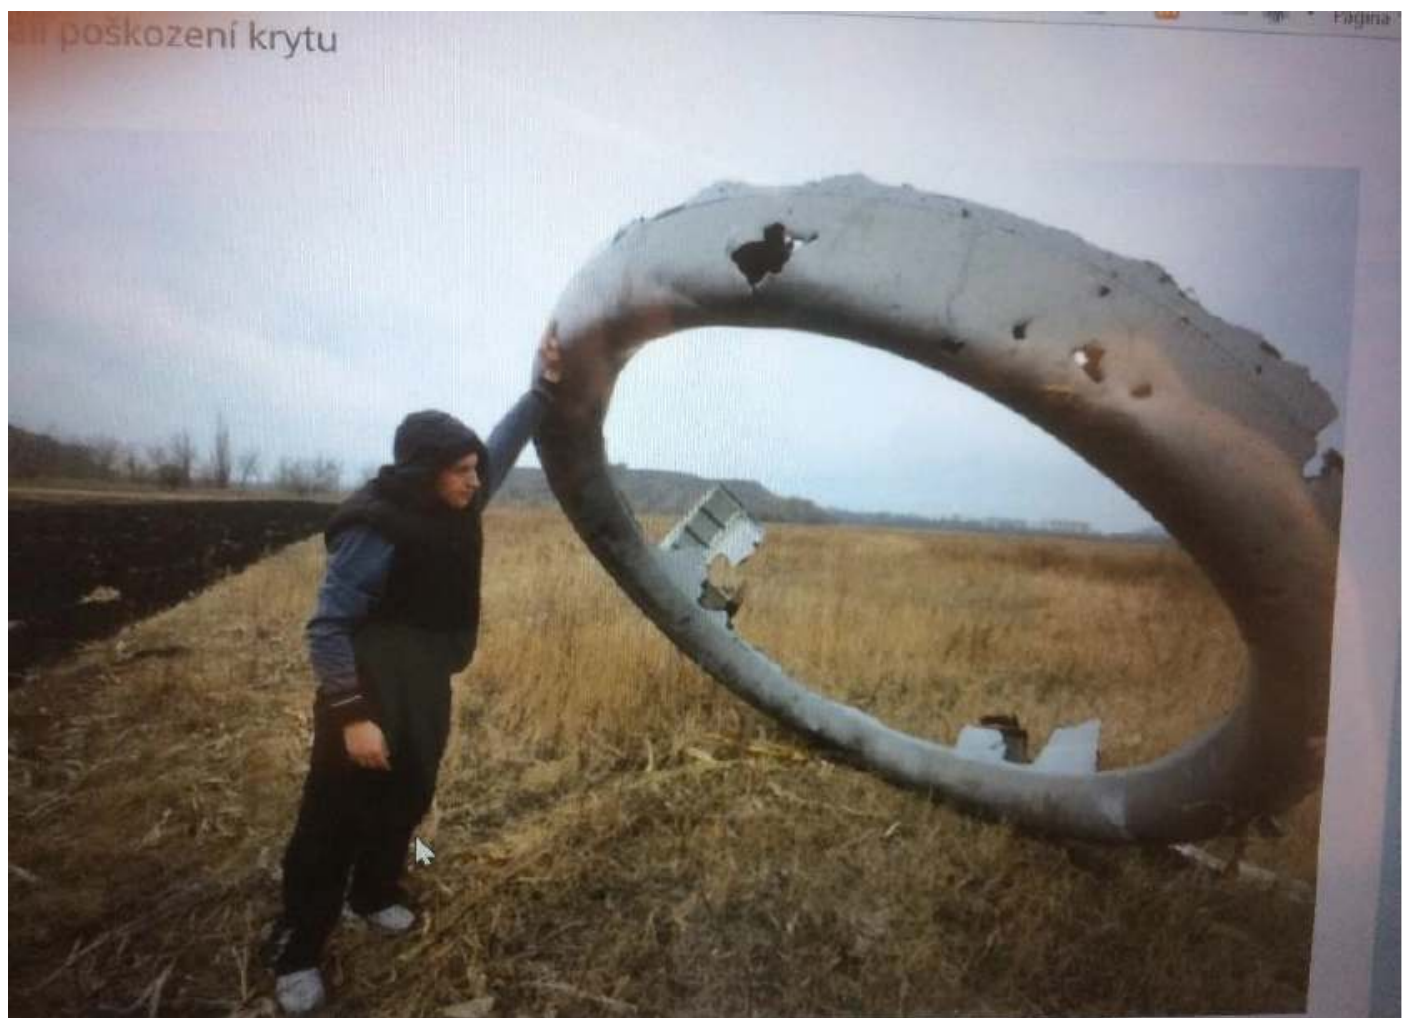
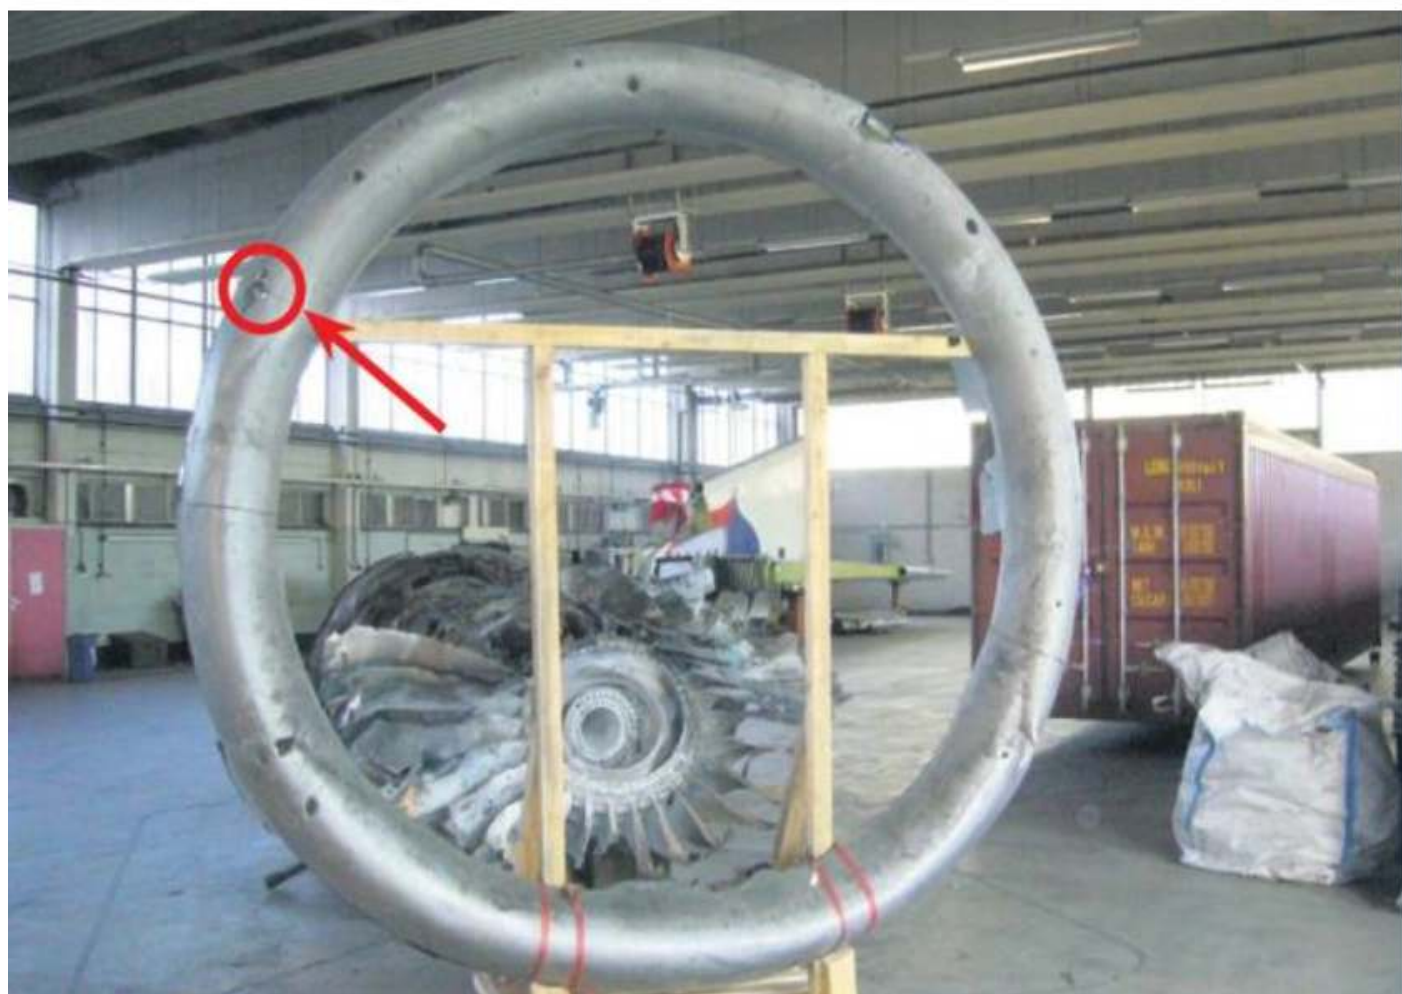
## Left engine inlet ring damage analysis

The left engine inlet ring displays 47 impact marks ranging from 1 to 200 mm in size. These impacts cannot be attributed to the secondary fragmentation pattern of a Buk missile, as their quantity is implausibly high. With a surface area of approximately 3 m<sup>2</sup> positioned over 20 meters from the missile's detonation point, the expected fragmentation dispersion area at this distance would cover about 150 m<sup>2</sup>. This would necessitate approximately 2,500 fragments—a number inconsistent with documented evidence. Had such fragmentation occurred, hundreds of impacts should be evident on the engine blades, left wing, and front left fuselage section of MH17. No such impacts were observed. Crucially, during the Almaz-Antei test conducted at the precise distance of 21 meters, the ring sustained zero impacts—not a single hit was recorded.

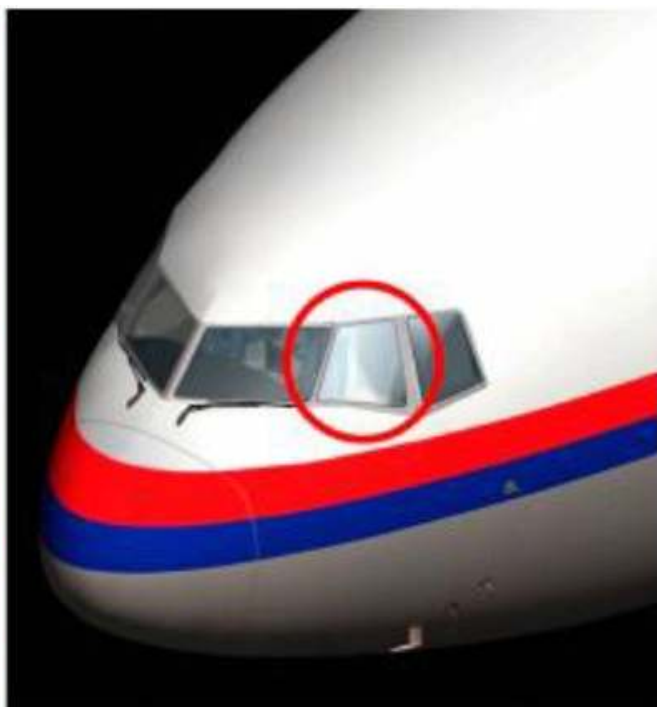
## Left cockpit window damage

29. The Dutch Safety Board (DSB) documented 102 impacts and concluded that the density must have exceeded 250 impacts per square meter (DSB Final Report, p.39). Excluding the window frame, this density rises beyond 300 impacts per square meter. Post-detonation, Buk missile particles disperse across approximately 80 to 100 m<sup>2</sup> at a 4-meter distance.

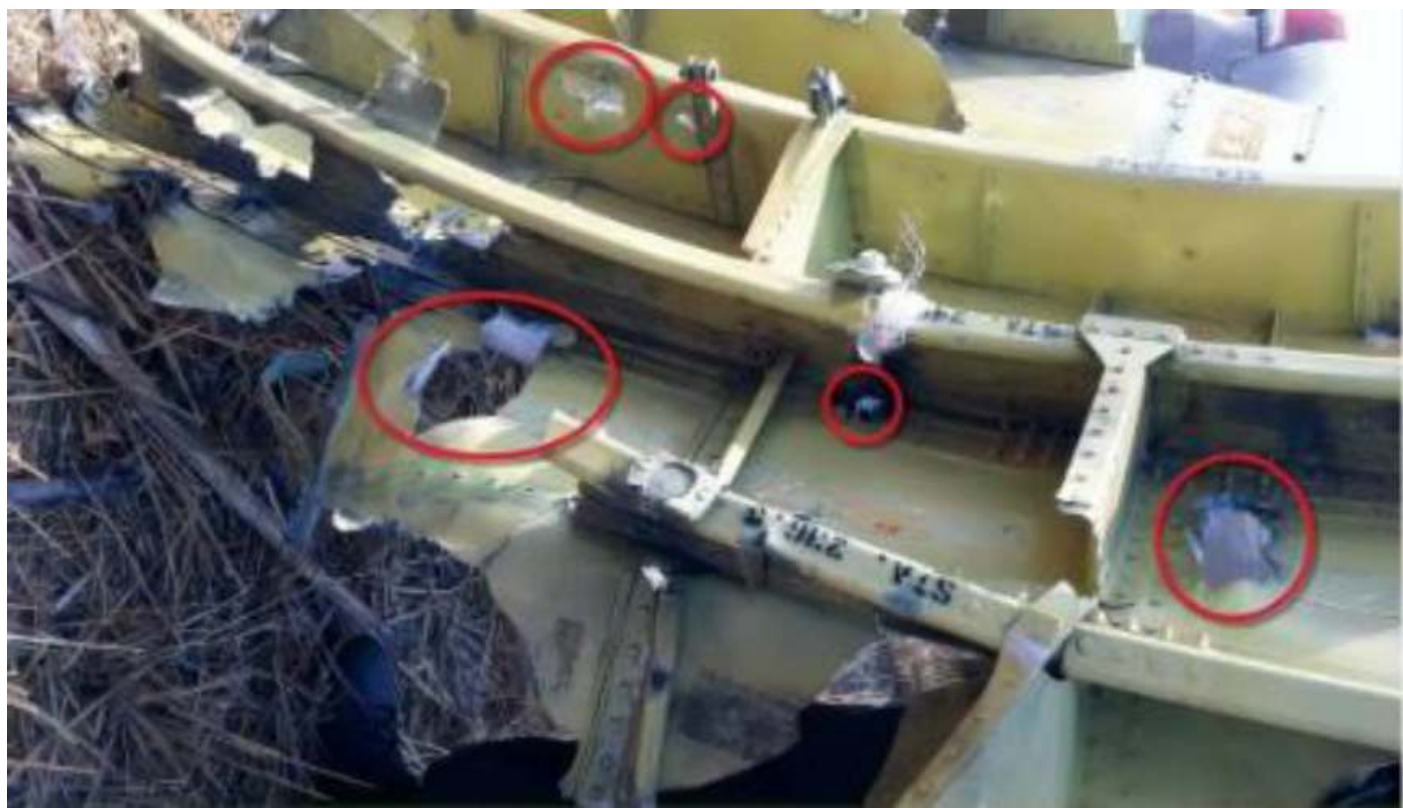
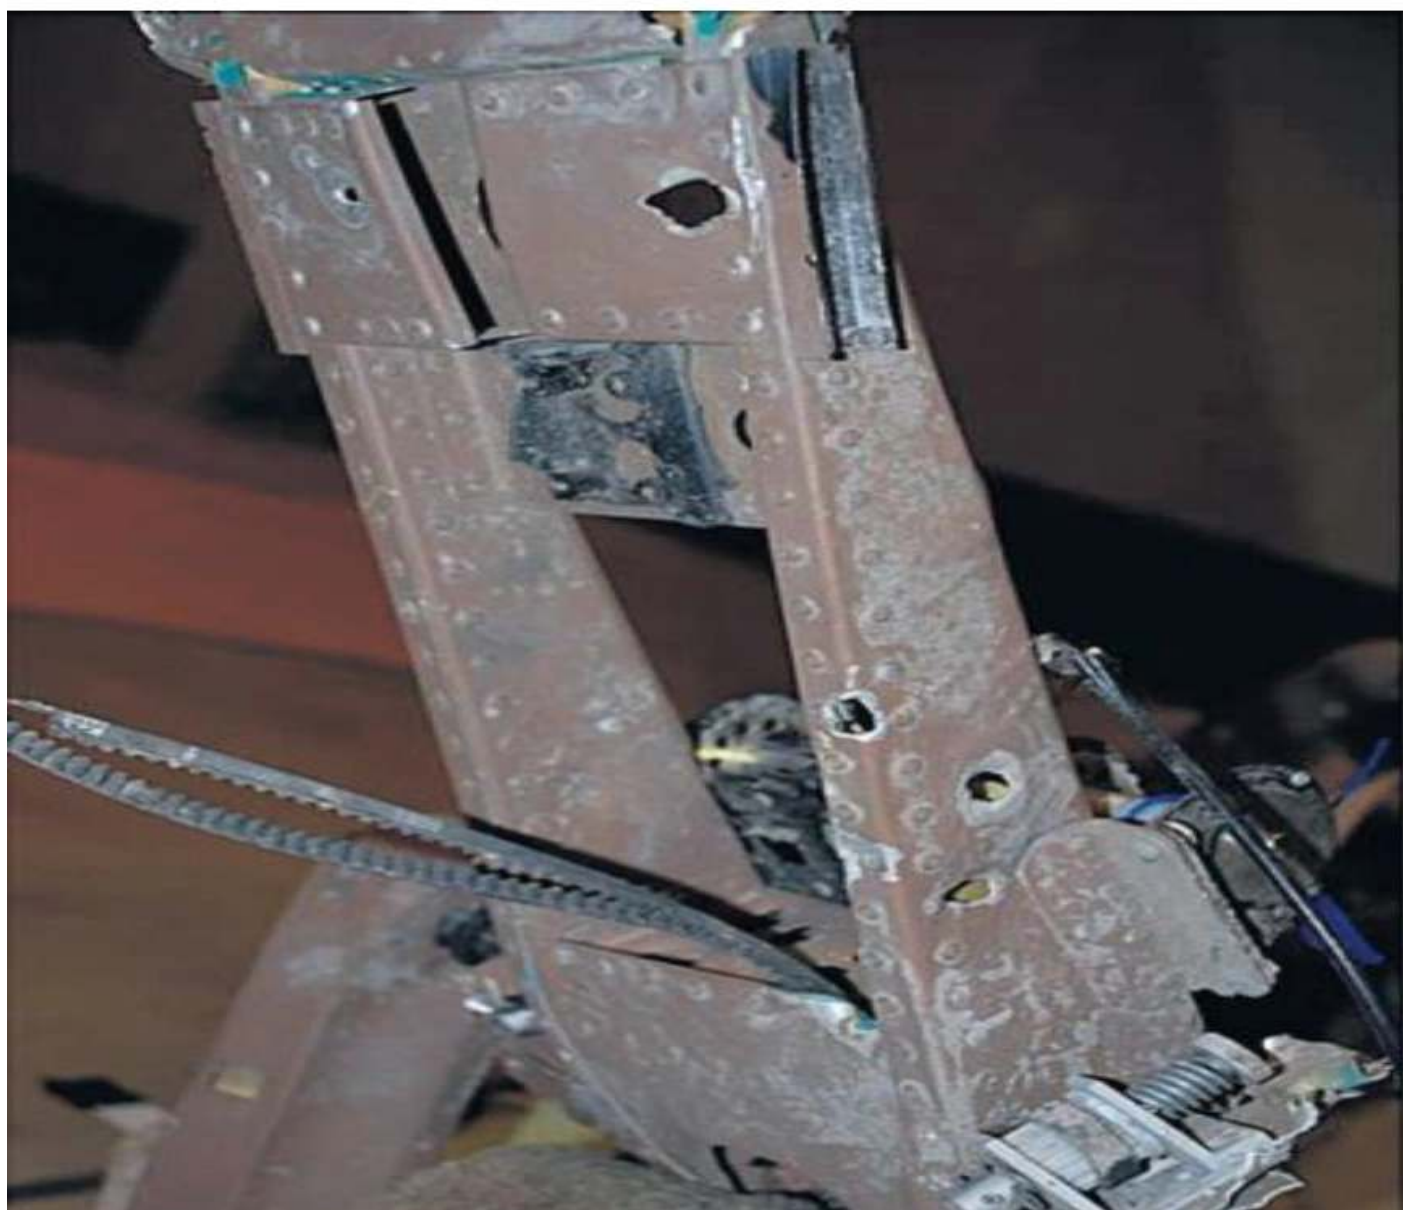
Damage patterns inconsistent with Buk missile fragmentation

Figure 15 on page 61 of the DSB Report shows two 30 mm holes in the top left section of the cockpit fuselage. Such damage is inconsistent with the fragmentation pattern of a Buk missile warhead.

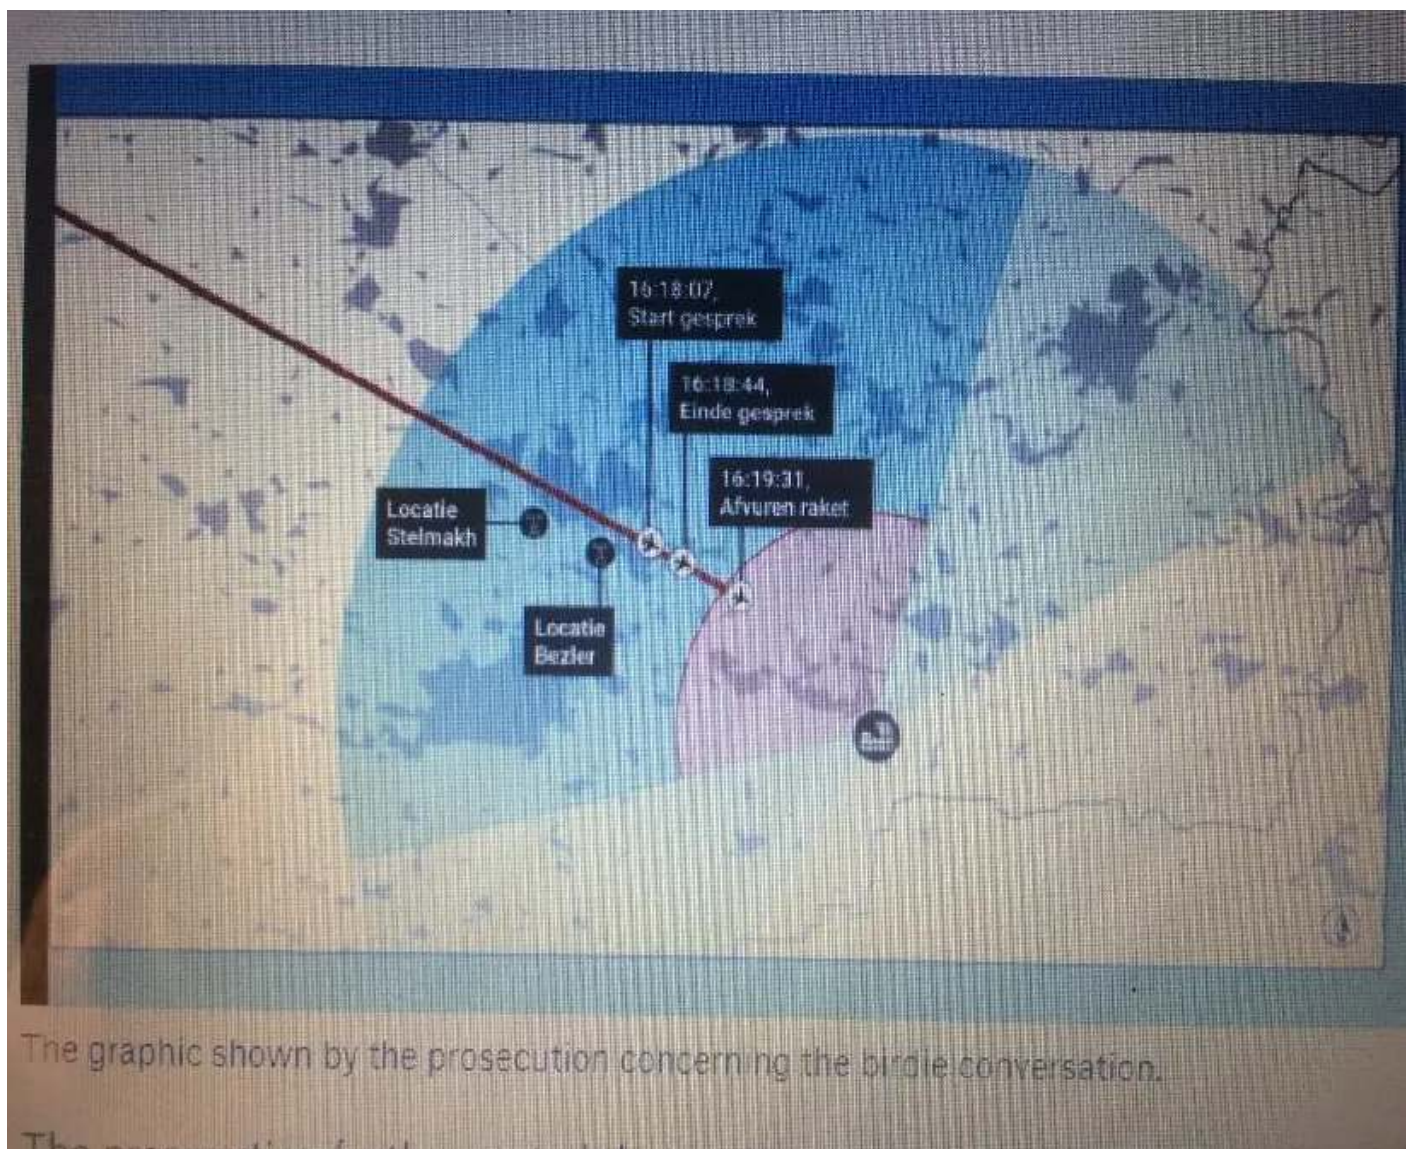
Even optimistically: Immediate detection by the Buk-TELAR allows under 16 seconds for the firing sequence. Realistically, detection at 40 km distance leaves less than 8 seconds. Therefore, solving the functional delay by reducing missile speed creates a temporal impossibility.

Diagram illustrating missile trajectory and timing constraints

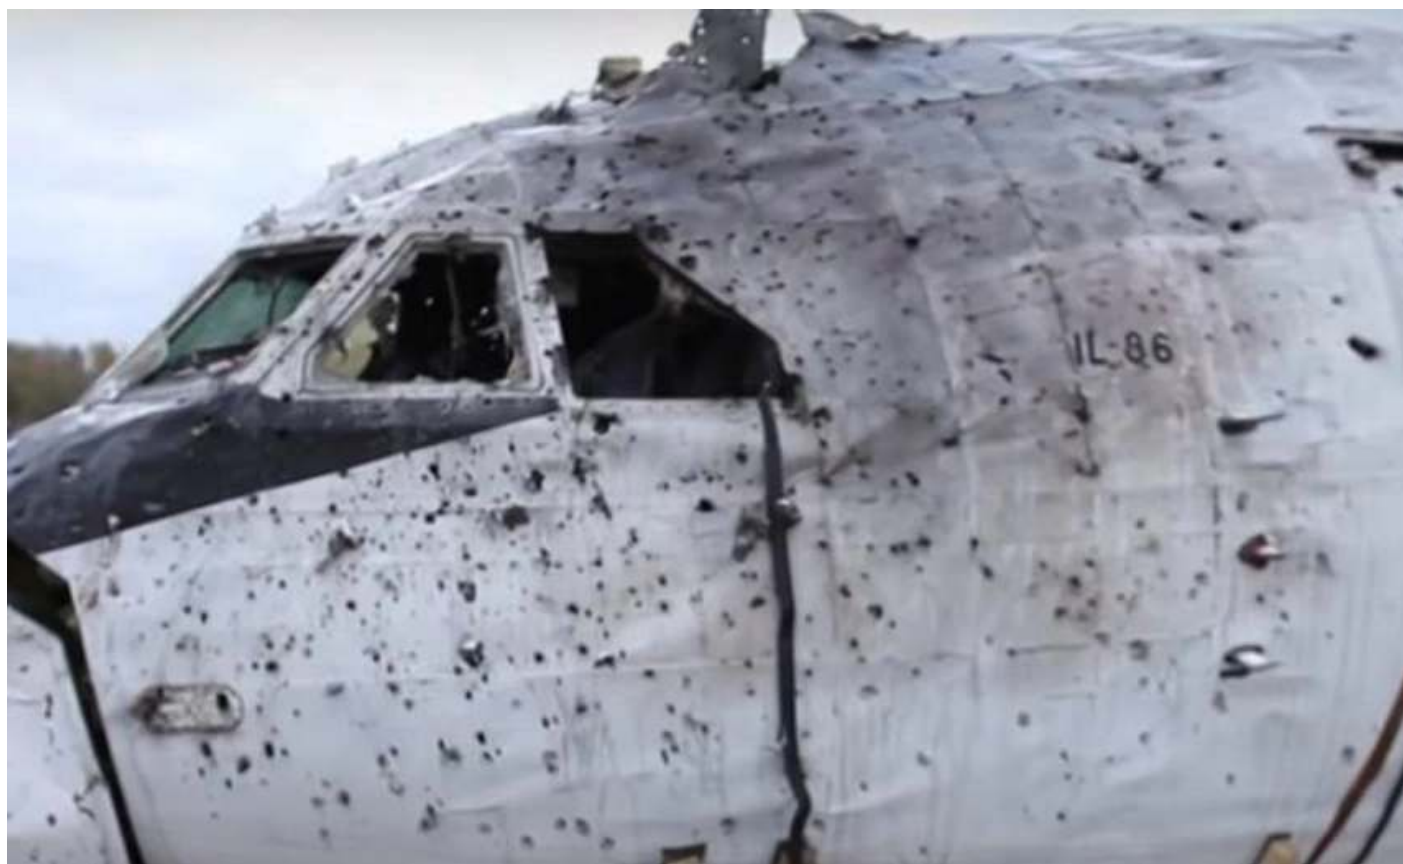
Arena test configuration: Aluminum plates at 10 meters. Why not use an actual cockpit like Almaz-Antei? Why not replicate the 4-meter detonation distance? Why position the inlet ring at 5 meters instead of 21 meters? Why omit dual-layer aluminum present throughout cockpits? Why avoid comparing 500 Buk particles with crew body fragments?

Almaz-Antei test outcome: Cockpit displays minor denting. Center cockpit window shattered. Uniform pattern of bowtie and square impacts. Absence of 30 mm holes.

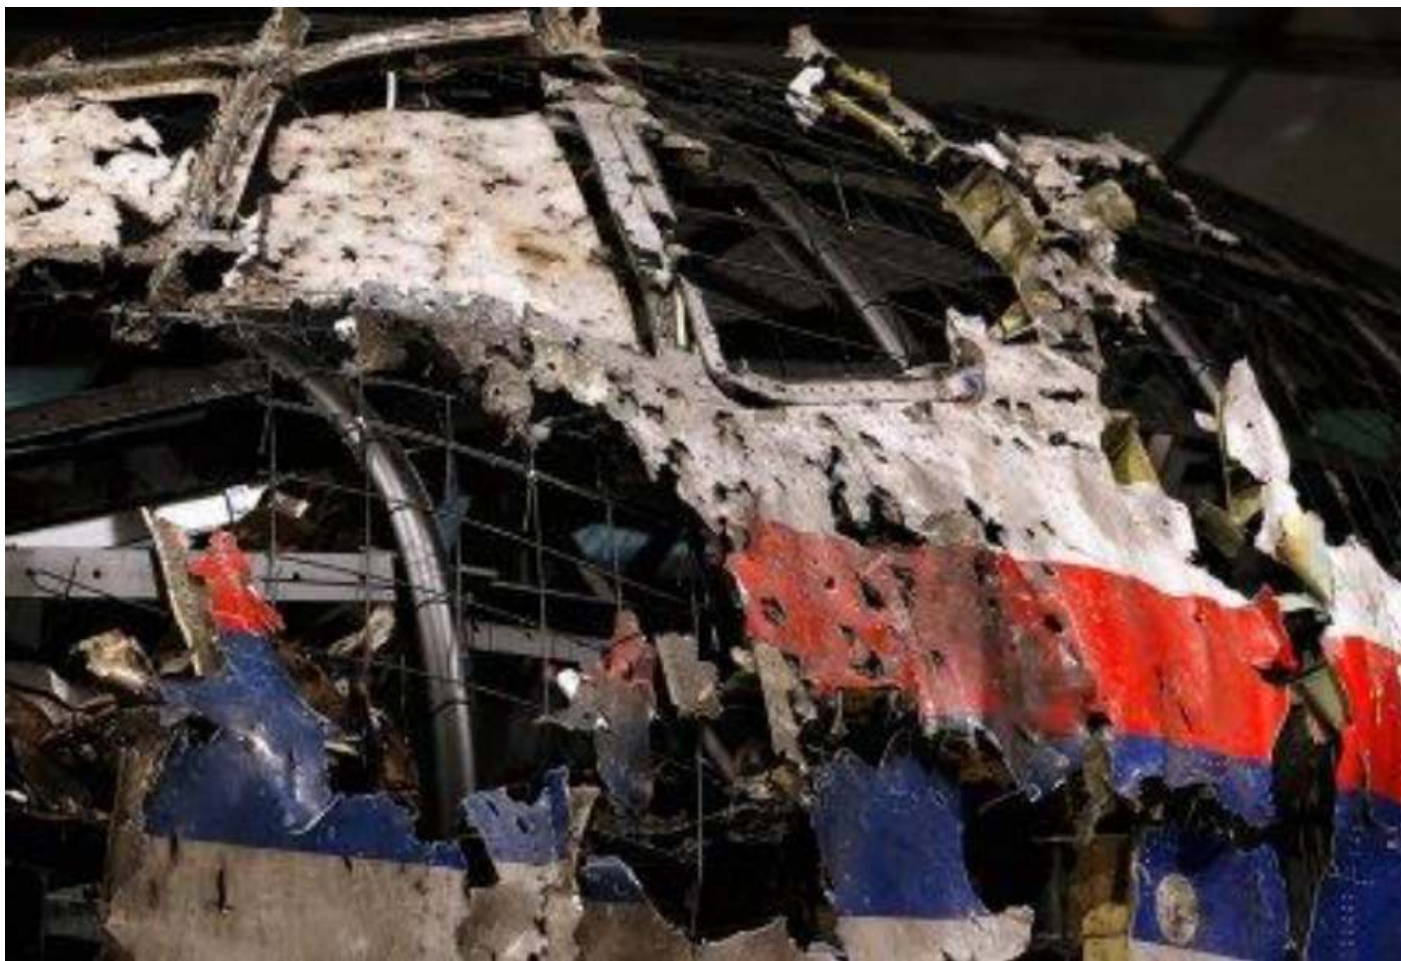
**MH17** evidence: 102 impacts on center cockpit window—nearly triple the expected distribution. Presence of 30 mm entry/exit holes.
